## Lydeard St Lawrence Church -cockerel weathervane -December 2020

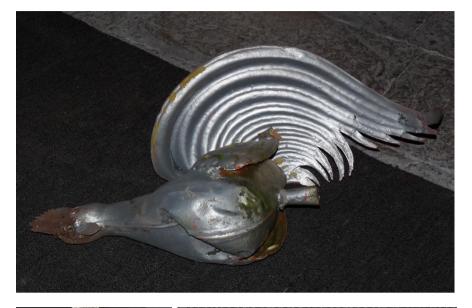
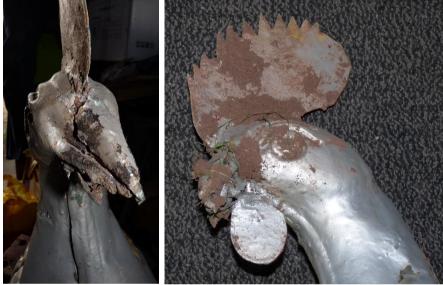
The cockerel blew down from the church tower in December 2018, hitting the roof and landing on the ground near the south porch. The supporting pole also came down and pierced the slates, coming to rest halfway through the roof, during the school good work assembly.

We discovered that the bird was constructed from copper sheet, soldered together, with a solid lead counterweight in the head. There was evidence of previous repairs suggesting that this is not the first time it has tumbled, and that the joint with the tail may have failed before. There were several layers of paint on it, suggesting that it has been gold, yellow, orange and silver at different times in its life. The construction suggests that it dates from Victorian times or earlier. pushed back towards the tail, several joints had split and there were numerous dents.

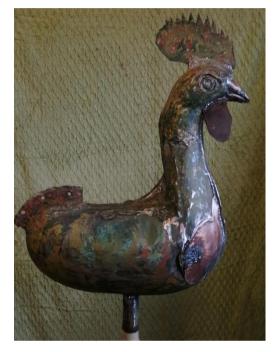
The damage was considerable and deciding how to repair it was not easy. It is made from copper, which hardens when it is bent so is liable to crack when bent back. Before attempting to bend it back it is best to anneal the copper, but this entails heating it to 700 degrees centigrade and letting it cool, at which temperature all the solder and lead would have melted and run away.

First the badly bent sections of the tail and wings were annealed so that they could be bent back

into shape. Then a car jack was used to push the neck forward as far as it would without cracking the copper

body. A home-made puller reshaped the dent in the chest, as far as necessary to realign the central joint, using an existing hole from a previous repair that had been covered with filler.
